# St. Lucie Nuclear Plant

## Inspect "Y" Diffuser

**Client/Owner:** Florida Power & Light  
**Project Location:** Jensen Beach, Florida

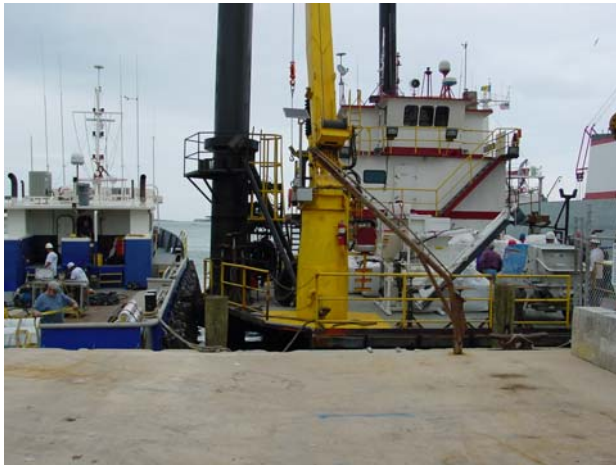
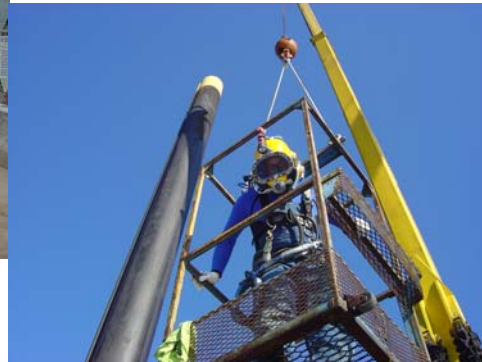
UES provided design build services to design and implement a repair to one of two ocean outfalls offshore of the St. Lucie Nuclear power plant. The velocity of the outfall created a scour hole that had eroded material from under the end of outfall pipe in 45 feet of water. The client contacted UES in September and requested phase 1 of the repair to be implemented by the end of December.

After the design of the repair the selection of a vessel able to handle anticipated sea states lead to the chartering of a lift vessel, which typically worked support for the oil industry in the Gulf of Mexico. The vessel was floated into place and then lifted above the seas on the vessels "legs." Dive operations were performed utilized a mixed gas, which allowed for longer bottom times for the commercial divers. First step was installing a series of jacks for the safety of the dive crew. UES then installed fabric form bags under the pipe, which are filled with an anti-washout concrete. Anti-washout concrete was tremie poured into additional void areas that could not be filled with the fabric form bags. Anti-washout concrete was produced by a small batch plant with an auger screw mixer. Individual concrete blocks were placed under the eastern most bag and woven together with a polyester rope for inclusion into additional articulating block mats to be placed during phase 2 of the repair. Repair was implemented ahead of schedule.
