# Florida Department of Transportation - Scour Repairs

**Client/Owner:** Florida Department of Transportation

**Project Location:** Hillsborough County, Florida

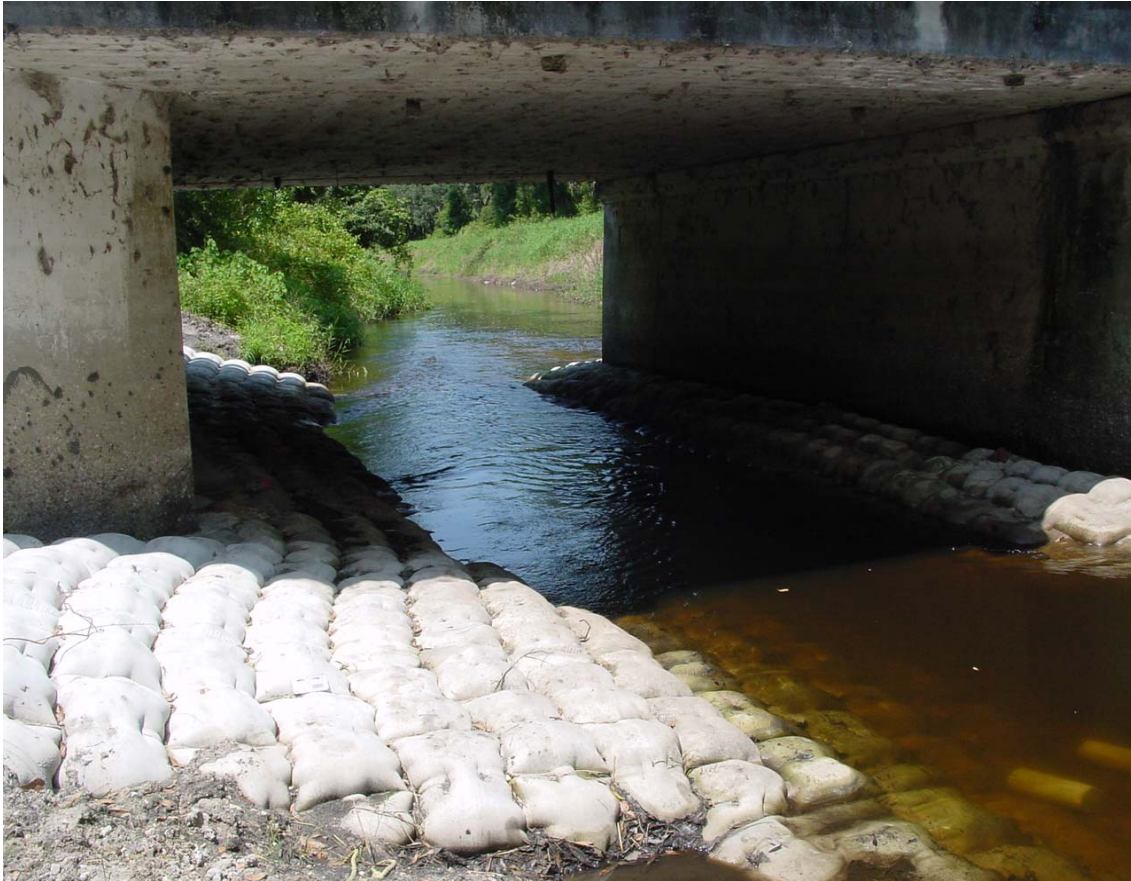
Erosion Control - Fabric Form

UESI as a prime contractor to FL DOT performed the debris removal, grading, fill and limestone placement to restore consistent flow lines beneath 6 bridges. After obtaining final grade an articulating, pump in place, fabric form mat was installed over a geotextile filter fabric to specification including 2 foot anchor trenches. Project location was Hillsborough County in the eastern Tampa / Brandon area. Project difficulties included performing work during intermittent periods of strong currents including one heavy flood occurrence that brought water levels to within 1.5' of the bridge deck at which we were working. Three of the sites were adjacent to designated wetland areas. All work completed in compliance with FL DOT CTQP program.
